Coakley Consulting Engineers

Whitebox Student Campus,
Groody Road, Newcastle,
Castletroy, Co. Limerick

Stage 1 Quality Audit

Stage 1 Road Safety Audit

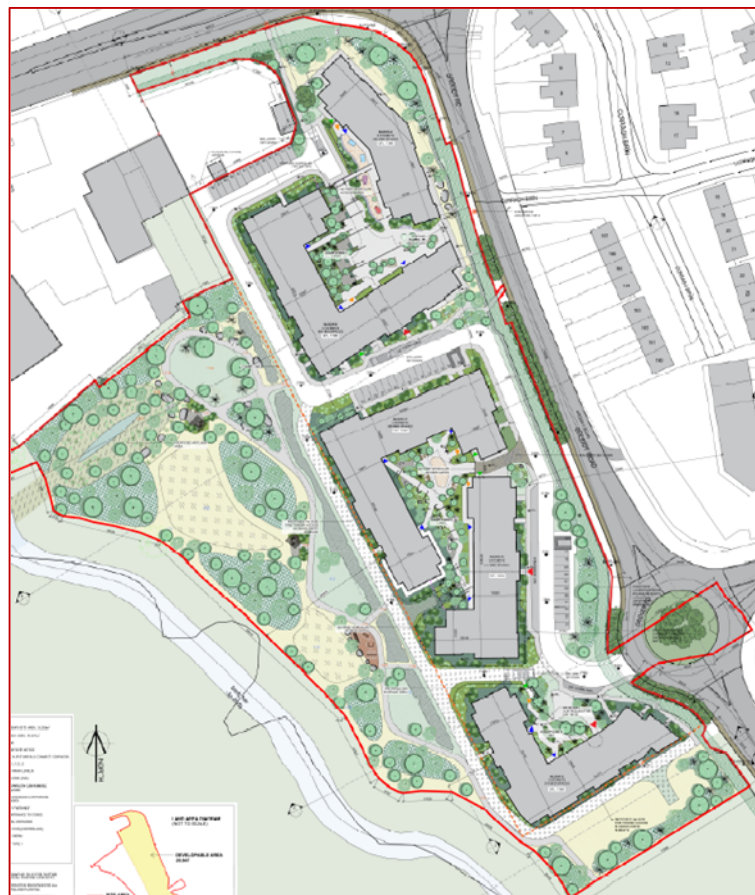
FIGURE 1-2: PROPOSED DEVELOPMENT LAYOUT (DRAWING PP-1.01 (REV.-))

The development shall have one vehicular which would form a new western arm at the existing Groody Road/Curragh Birin roundabout, and three pedestrian accesses, including two onto Groody Road and one onto Dublin Road. The proposed development would include five multistorey apartment blocks including a total of 1,400 beds, an internal road and footpath network within the development, public open spaces, 40 on-street

car parking spaces, including two accessible parking spaces, and two set down areas. Cyclists would be required to share the carriageway with motorised road users within the proposed development.

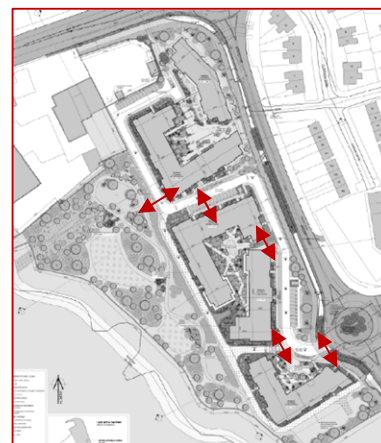
2.1 Pedestrian Desire Lines within the Development

Pedestrian crossings have not been indicated at pedestrian desire lines within the development. No pedestrian crossings have been indicated at the following locations:

- Between the central public open spaces and the surrounding residential development/.
- Between parking spaces and the footpath on the opposite side of the road.
- At the development access and internal vehicular accesses.

A failure to provide an appropriate crossing for non-motorised road users at these expected desire lines could result in difficulties when crossing the carriageway, particularly for mobility and visually impaired pedestrians.

A thorough review of the likely pedestrian desire lines within the development should be undertaken, and suitable pedestrian crossings, including dropped kerbs and tactile paving, provided to facilitate safe VRU movement.

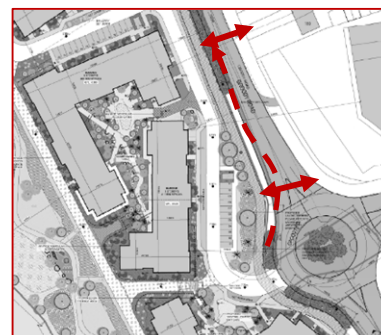
2.2 Pedestrian Desire Lines to/from the Footpath on Groody Road

It is likely that pedestrian desire lines will exist between the proposed development and the neighbouring residential area to the east on the opposite side of Groody Road. Two pedestrian accesses to the proposed development have been indicated on Groody Road, however, no footpath is currently provided on the western side of Groody Road, nor are any pedestrian crossings provided, or proposed, connecting the development with Curragh Birin, including at the Groody Road/Curragh Birin roundabout.

If pedestrian facilities, including footpaths and formal pedestrian crossings, with dropped kerbs and tactile paving, are not provided on Groody Road, this may lead to difficulties for pedestrians, particularly the mobility and visually impaired, such as wheelchair users, in independently navigating the road layout.

Pedestrian facilities should be provided on Groody Road, including a footpath on the western side of the road and pedestrian crossings, with dropped kerb and associated tactile paving, to cater for pedestrian desire lines.

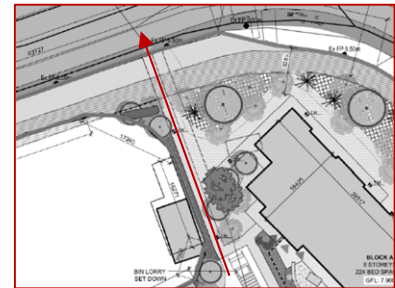
2.3 Steep Gradient

A pedestrian access onto the footpath on the southern side of Dublin Road has been indicated at the northern boundary of the proposed development. Due to the existing level difference between the land within the development site and this footpath it is unclear if the gradient of this path would be suitable for all pedestrians, particularly the mobility impaired. Should the path gradient exceed 1V:20H, it will create difficulties for mobility impaired pedestrians to traverse.

Ensure the proposed ramp gradients are suitable for all road users.

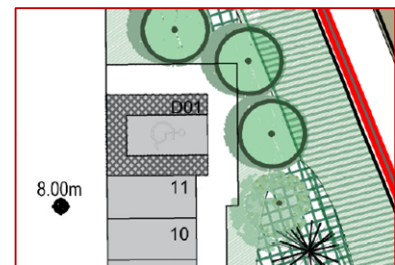
2.4 No Dropped Kerb/Tactile Paving at Accessible Parking Spaces

Two accessible parking spaces have been indicated within the proposed development. Dropped kerbs, and tactile paving, have not been indicated at these parking spaces. This may lead to mobility impaired vehicle occupants having to travel within the carriageway to a suitable location to access the footpath, which may be a lengthy journey, or have to mount/dismount full height kerbs to access a footpath.

Dropped kerbs, and tactile paving, should be provided adjacent to accessible parking spaces.

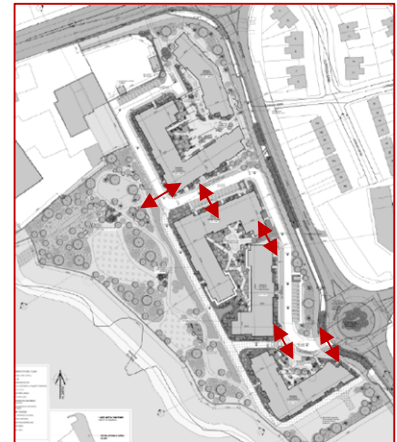
3.1 Pedestrian Desire Lines within the Development

Pedestrian crossings have not been indicated at pedestrian desire lines within the development. No pedestrian crossings have been indicated at the following locations:

- Between the central public open spaces and the surrounding residential development.
- Between parking spaces and the footpath on the opposite side of the road.
- At the development access and internal vehicular accesses.

A failure to provide an appropriate crossing for non-motorised users at these expected desire lines could result in difficulties in crossing the carriageway, particularly for mobility and visually impaired pedestrians.

A thorough review of likely pedestrian desire lines within the development should be undertaken, and suitable pedestrian crossings, including dropped kerbs and tactile paving, provided to facilitate safe VRU movement.

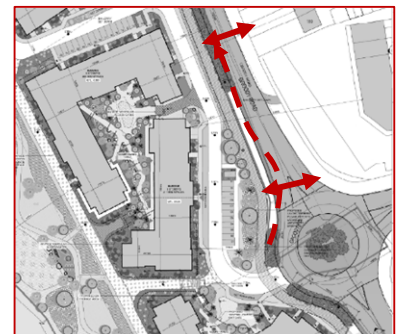
3.2 Pedestrian Desire Lines to/from the Footpath on Groody Road

It is likely that pedestrian desire lines will exist between the proposed development and the neighbouring residential area to the east on the opposite side of Groody Road. Two pedestrian accesses to the proposed development have been indicated on Groody Road, however, no footpath is currently provided on the western side of Groody Road nor are any pedestrian crossings provided, or proposed, connecting the development with Curragh Birin, including at the Groody Road/Curragh Birin roundabout.

If pedestrian facilities, including footpaths and formal pedestrian crossings, with dropped kerbs and tactile paving, are not provided on Groody Road, this may lead to difficulties for pedestrians, particularly the mobility and visually impaired, such as wheelchair users, in independently navigating the road layout.

Pedestrian facilities should be provided on Groody Road, including a footpath on the western side of the road and pedestrian crossings, including dropped kerb and associated tactile paving, to cater for pedestrian desire lines.

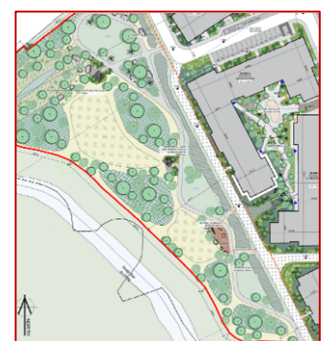
3.3 Absence of Seating on Groody Valley

No seating or benches have been indicated within the public open spaces and paths on Groody Valley. Pedestrians, particularly the mobility impaired, may have difficulties walking, or standing, for long periods leading to fatigue.

Seating should be provided within public open spaces and courtyards.

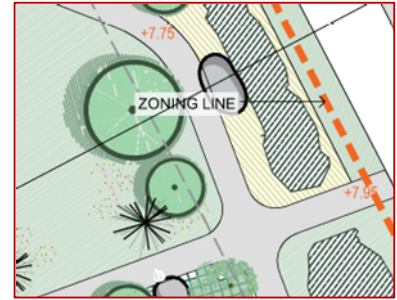
3.4 Mounting Height of Tree Canopies

Information regarding the mounting height of tree canopies, located within the development and on Groody Valley public open space area, has not been provided to the Auditor. It is, therefore, unclear if there will be sufficient vertical clearance between the tree canopies and the footpath should trees overhang these pedestrian facilities.

If sufficient vertical clearance is not provided there is a risk that the tree canopies could present an obstacle to pedestrians.

Tree canopies should have a clear vertical clearance of 2.3m above footpaths.

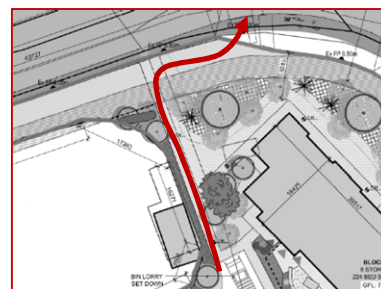
4.3 Absence of Cycle Route between the Development and Dublin Road

Existing cycle facilities and a Zebra crossing are provided on Dublin Road connecting the University of Limerick with Groody Roundabout. Whilst a pedestrian access onto the footpath on the southern side of Dublin Road has been indicated at the northern boundary of the proposed development, a route, and access, for cyclists has not been indicated at this location.

It is, therefore, likely to result in cyclists travelling within the footpath between Dublin Road and the development. The width of the proposed pedestrian route at this location would be insufficient for use by both pedestrians and cyclists resulting in conflicts between these road users.

The path connecting Dublin Road and the proposed development should be wide enough to cater for the expected types and volumes of non-motorised road users, including the provision of shared path sections on the route between Dublin Road and the proposed development.

'Ladder & Tramline' tactile paving should be provided where the shared paths would transition to pedestrian-only paths.

The ramp gradient at this location (see Issue 2.3) should also be suitable for cyclists.

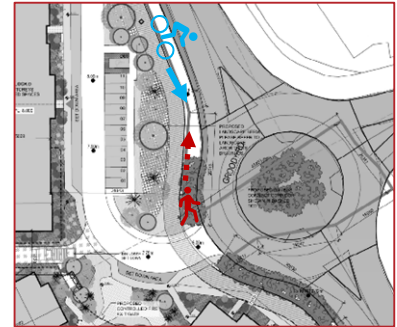
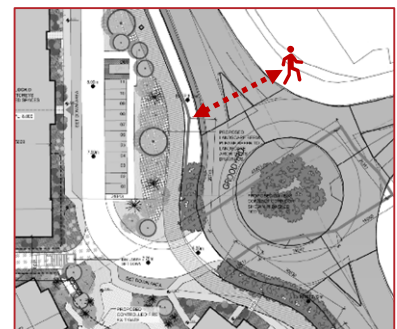
There are also currently no pedestrian crossings at the roundabout at the proposed development access, which was noted as extremely busy at the time of the site visit, further exacerbating the problem.

In addition, the lack of a footpath on the western side of Groody Road will likely lead to pedestrians travelling in the verge or protected northbound cycle lane along the proposed development boundary, resulting in a risk of slips and falls, or pedestrian/cyclist collisions.

Measures should be provided to support the safe movement of pedestrians between the proposed development and developments on the eastern side of Groody Road.

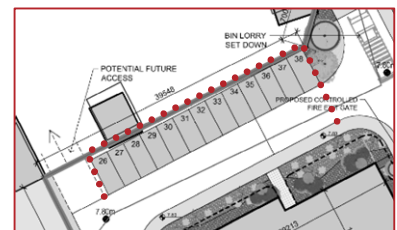
Summary: No footpath has been indicated around the parking spaces at the proposed development's northern boundary adjacent to Blocks A and B.

Parking spaces 26 – 38 have been indicated at the development's northern boundary adjacent to Blocks A and B. No footpath has been indicated adjacent to these parking spaces. The lack of a footpath at this location may lead to vehicle occupants travelling in the verge, which may rut over time, resulting in unstable ground and ponding, and an increased risk of slips, trips and falls.

Provide a paved footpath bounding these parking spaces and a pedestrian crossing to access the footpath on the opposite side of the road.

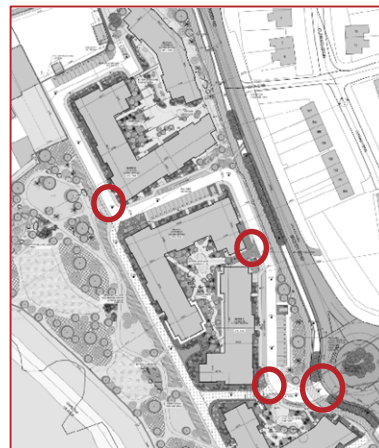
A failure to provide formal pedestrian crossings, with dropped kerbs and tactile paving, could lead to pedestrians crossing the carriageway at locations where drivers may be less attentive to them and insufficiently prepared to react safely resulting in an increased risk of vehicle-pedestrian collisions.

In addition, the lack of dropped kerbs and tactile paving at locations where pedestrians are likely to cross the carriageway would lead to pedestrians having to mount/dismount full height kerbs where there is a risk of trips and falls, and further accessibility issues for the visually and mobility impaired.

Pedestrian crossings, including dropped kerbs and tactile paving, should be provided at the development access and across side road junctions within the development.

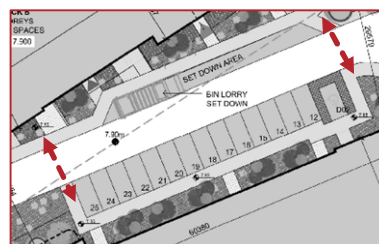
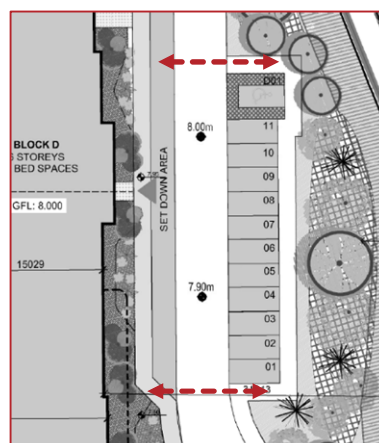
Parking spaces have been indicated within the proposed development on the opposite side of the development access road to the main entrance to Blocks B and D. Formal pedestrian crossings have not been indicated adjacent to these parking spaces to accommodate vehicle occupants crossing between their vehicle and the apartment blocks. A failure to provide a formal pedestrian crossing, with dropped kerbs and tactile paving, at these locations could lead to pedestrians, particularly mobility impaired pedestrians, being unable to safely and independently enter the carriageway to cross to the opposite footpath.

Formal pedestrian crossings, including dropped kerbs and tactile paving, should be provided at pedestrian desire lines between the proposed parking spaces and the opposite footpath adjacent the main apartment block entrances.

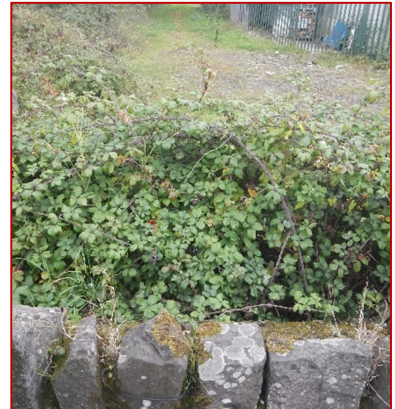
Summary: *The existing level difference between the site and the adjacent public footpath on the southern side of the R445 may result in a steep gradient on the proposed pedestrian path between the R445 and the development.*

A pedestrian route from the proposed development to the footpath on the southern side of the R445 has been indicated at the development's northern boundary. At the time of the site visit, the Audit Team noted a level difference between the development site and the footpath on the R445. It is, therefore, unclear if the gradient of this access path would be suitable for all pedestrians, particularly the mobility impaired. If not, this may increase the risk of slips, trips and falls and personal injuries.

The access path should have a smooth, non-slip surface and should provide a gentle gradient that can be safely traversed by all road users.

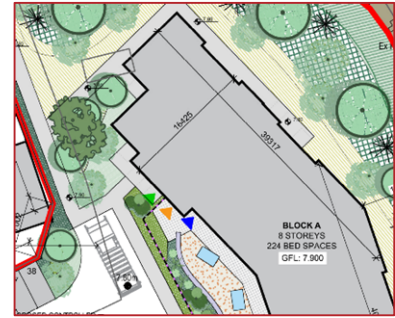
- 4.1 The Main Lobby Entrances have not been indicated at Blocks A and C. It is, therefore, unclear how pedestrians will access these blocks, i.e. from the development's internal footpath network or from routes between other apartment blocks. The Main Lobby Entrances should be clearly marked on the drawings and sufficient routes provided to these locations.
