Whitebox Student Campus,
Groody Road, Newcastle,
Castletroy, Co. Limerick

Stage 1 Road Safety Audit

| Document Ref: | P24170-PMCE-XX-XX-RP-SA-3_0001 |

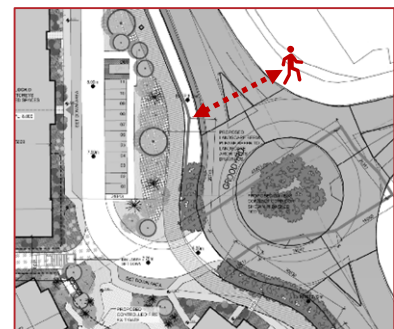
Location: Drawing no. PP-1.01

Summary: No pedestrian crossings have been indicated to/from the proposed development on Groody Road.

It is proposed to construct the student accommodation development on the western side of Groody Road with two pedestrian accesses indicated onto this side of the road, however, there is currently no footpath along the western side of Groody Road with an existing public footpath provided along the opposite side only. A pedestrian crossing has not been indicated on Groody Road with the nearest crossing being the Zebra crossing at the Groody Roundabout approximately 200m to the north.

There is likely to be a pedestrian desire line between the proposed development and the shops/residential developments on the eastern side of Groody Road, and it is unlikely that residents of the proposed development would travel north to this crossing. This may lead to pedestrians, who wish to travel between these developments, crossing Groody Road at locations where a driver may be less attentive to them, and insufficiently prepared to react, resulting in an increased risk of vehicle-pedestrian collisions.

There are also currently no pedestrian crossings at the roundabout at the proposed development access, which was noted as extremely busy at the time of the site visit, further exacerbating the problem.

In addition, the lack of a footpath on the western side of Groody Road will likely lead to pedestrians travelling in the verge or protected northbound cycle lane along the proposed development boundary, resulting in a risk of slips and falls, or pedestrian/cyclist collisions.

Measures should be provided to support the safe movement of pedestrians between the proposed development and developments on the eastern side of Groody Road.

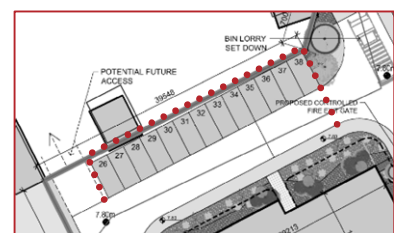
Location: Drawing no. PP-1.01

Summary: No footpath has been indicated around the parking spaces at the proposed development's northern boundary adjacent to Blocks A and B.

Parking spaces 26 – 38 have been indicated at the development's northern boundary adjacent to Blocks A and B. No footpath has been indicated adjacent to these parking spaces. The lack of a footpath at this location may lead to vehicle occupants travelling in the verge, which may rut over time, resulting in unstable ground and ponding, and an increased risk of slips, trips and falls.

Provide a paved footpath bounding these parking spaces and a pedestrian crossing to access the footpath on the opposite side of the road.

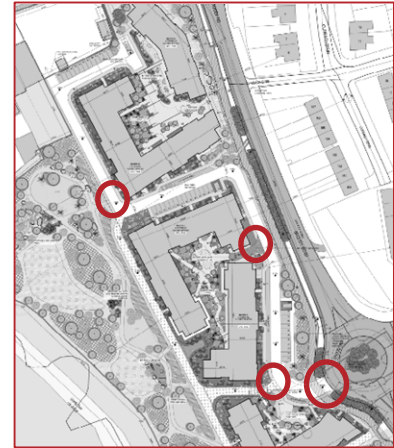
Location: Drawing no. PP-1.01

Summary: Details of pedestrian crossings within the development have not been indicated.

Pedestrian crossings have not been indicated within the development particularly at the development access and internal junctions where it is likely that these will be required to cater for pedestrians crossing the internal road network.

A failure to provide formal pedestrian crossings, with dropped kerbs and tactile paving, could lead to pedestrians crossing the carriageway at locations where drivers may be less attentive to them and insufficiently prepared to react safely resulting in an increased risk of vehicle-pedestrian collisions.

In addition, the lack of dropped kerbs and tactile paving at locations where pedestrians are likely to cross the carriageway would lead to pedestrians having to mount/dismount full height kerbs where there is a risk of trips and falls, and further accessibility issues for the visually and mobility impaired.

Pedestrian crossings, including dropped kerbs and tactile paving, should be provided at the development access and across side road junctions within the development.

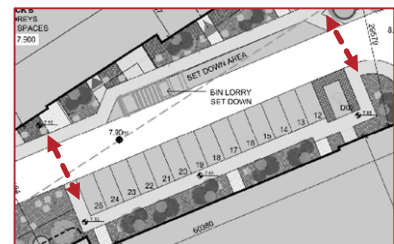
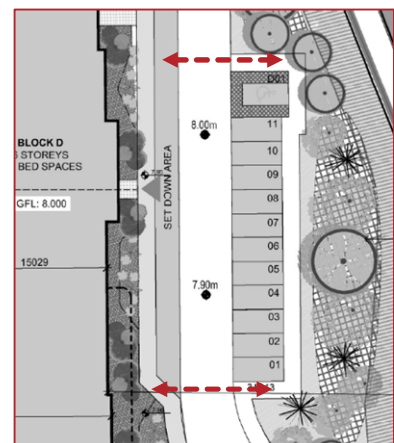
Location: Drawing no. PP-1.01

Summary: No pedestrian crossings have been indicated to cater for vehicle occupants travelling between their vehicle and the apartment blocks within the proposed development.

Parking spaces have been indicated within the proposed development on the opposite side of the development access road to the main entrance to Blocks B and D. Formal pedestrian crossings have not been indicated adjacent to these parking spaces to accommodate vehicle occupants crossing between their vehicle and the apartment blocks. A failure to provide a formal pedestrian crossing, with dropped kerbs and tactile paving, at these locations could lead to pedestrians, particularly mobility impaired pedestrians, being unable to safely and independently enter the carriageway to cross to the opposite footpath.

This could result in slips, trips and falls as these pedestrians attempt to descend the kerb, or an increased risk in visually impaired pedestrians unintentionally entering the carriageway where they could be struck by vehicles.

Formal pedestrian crossings, including dropped kerbs and tactile paving, should be provided at pedestrian desire lines between the proposed parking spaces and the opposite footpath adjacent the main apartment block entrances.

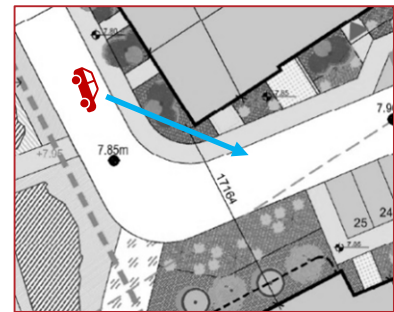
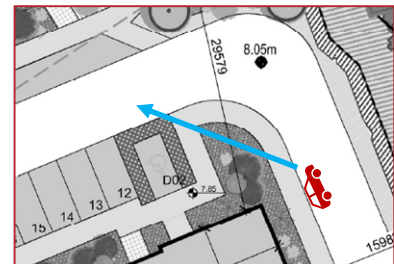
Location: Drawing no. PP-1.01

Summary: Forward visibility of drivers within the proposed development may be restricted by proposed planting and building boundaries on the inside of horizontal curves.

Horizontal curves have been indicated within the alignment of the development's internal access road between Blocks B and C. It is unclear if sufficient forward visibility will be available for drivers on the inside of these horizontal curves due to the trees and building boundaries located on the inside of the bend. This may lead to drivers being insufficiently aware of oncoming opposing traffic resulting in a risk of low-speed head on collisions.

Sufficient forward visibility should be provided for drivers on approach to, and throughout, the horizontal curves.

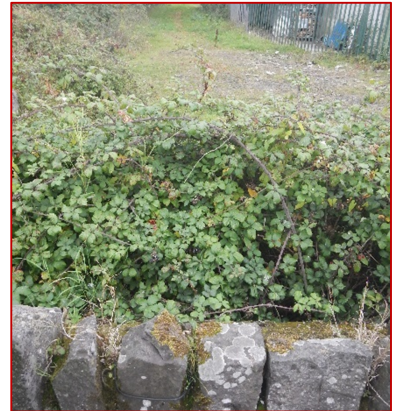
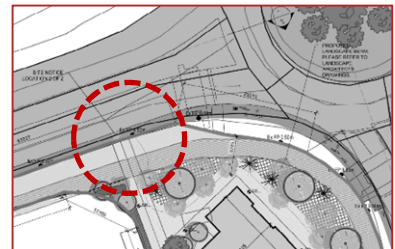
Location: Drawing no. PP-1.01

Summary: The existing level difference between the site and the adjacent public footpath on the southern side of the R445 may result in a steep gradient on the proposed pedestrian path between the R445 and the development.

A pedestrian route from the proposed development to the footpath on the southern side of the R445 has been indicated at the development's northern boundary. At the time of the site visit, the Audit Team noted a level difference between the development site and the footpath on the R445. It is, therefore, unclear if the gradient of this access path would be suitable for all pedestrians, particularly the mobility impaired. If not, this may increase the risk of slips, trips and falls and personal injuries.

The access path should have a smooth, non-slip surface and should provide a gentle gradient that can be safely traversed by all road users.

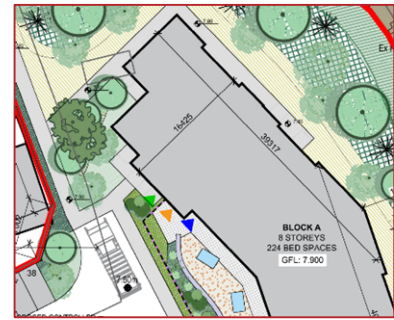
- 4.1 The Main Lobby Entrances have not been indicated at Blocks A and C. It is, therefore, unclear how pedestrians will access these blocks, i.e. from the development's internal footpath network or from routes between other apartment blocks. The Main Lobby Entrances should be clearly marked on the drawings and sufficient routes provided to these locations.
